A Review of Engine Seal Performance and Requirements for Current and Future Army Engine Platforms

Prepared for the
43rd Joint Propulsion Conference
cosponsored by the AIAA, ASME, SAE, and ASEE
Cincinnati, Ohio, July 8–11, 2007

Abstract

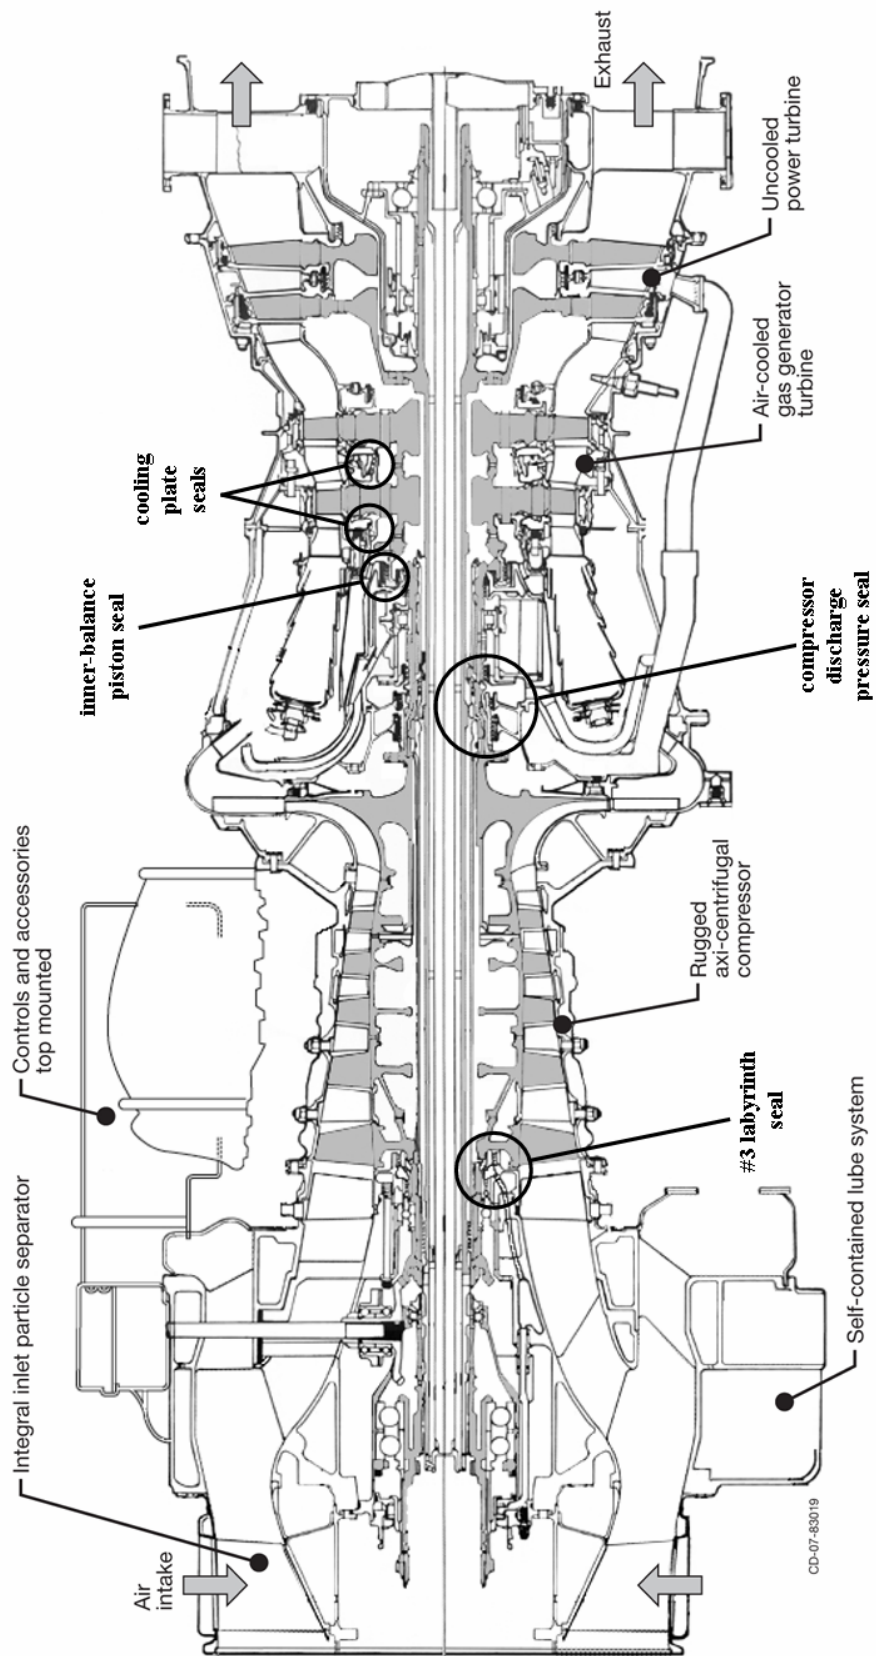
Figure 2.—T-700 Engine schematic showing locations of various labyrinth seals.

Data from 4 labyrinth seals taken from the T-700 overhaul facility at CCAD are discussed. They are the #3 labyrinth seal, the CDP seal, the IBP seal, and the labyrinth seals on the gas generator cooling plates, (fig. 2).

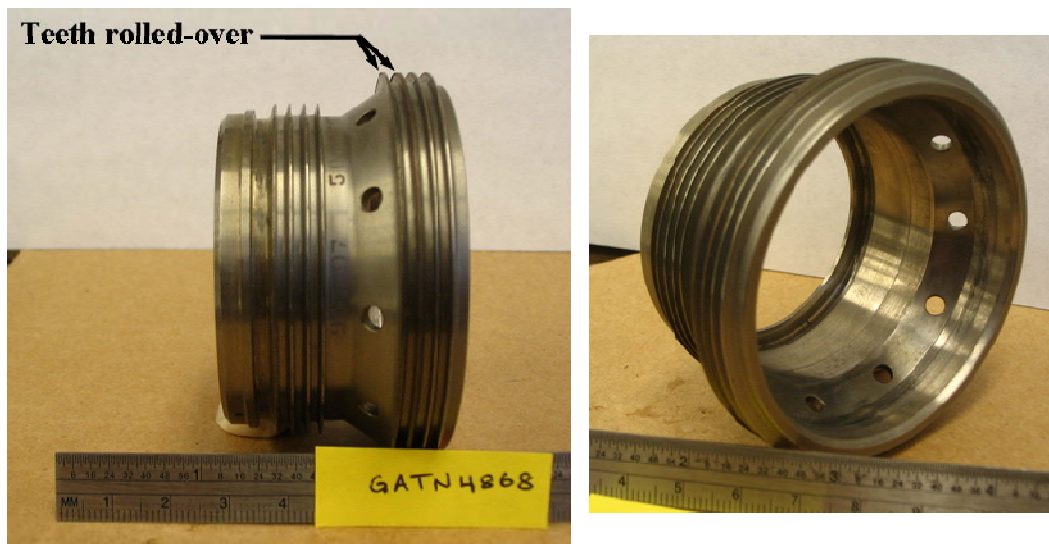
Figure 3.—No. 3 labyrinth seal.

The #3 labyrinth seal (fig. 3), composed of 2 sets of 4-knife labyrinth teeth, is located forward and radially inward from the 1st stage compressor. The forward labyrinth teeth seal the aft end of the forward or A-sump. Purge air is bled from the fourth stage compressor to a space between the 2 sets of teeth to separate the air and oil cavities. Air leakage through the rear labyrinth teeth is fed back into the compressor.

The #3 labyrinth seal is replaced if diametral wear limits on the labyrinth teeth are exceeded. The wear limits only apply to the labyrinth teeth directly adjacent to the bleed air inlet ports as shown in figure 3.

Three #3 labyrinth seals received from CCAD showed no visible signs of sand impaction. Operational hours varied from nearly 2000 to over 6000 hr and all three were marked “undersized”. Two of the three labyrinth seals exhibited labyrinth seal tooth tip roll-over on the first two teeth to the right of the air inlet ports as shown in figure 3.

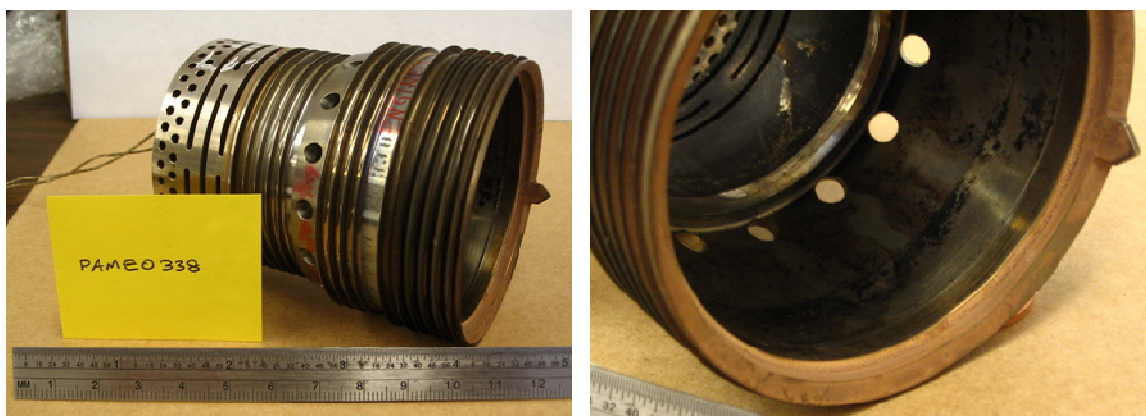
Figure 4.—Compressor discharge pressure seal with impacted sand.

The CDP seal (figs. 4 and 5) is composed of 3 sets of labyrinth teeth. CDP seal air leakage from the forward 7-knife labyrinth comes from impeller tip leakage and is ported to the turbine 4th stage shrouds. Fourth stage compressor bleed air feeds the cavity between the middle and rear CDP seal labyrinth teeth. This provides a positive air pressure to seal the forward end of the middle or B-sump. Air leakage from the middle labyrinth teeth is fed to the turbine 4th stage shrouds.

Three CDP seals were received from CCAD with operational hours ranging from 1600 to nearly 5000 hr. Evidence of impacted sand on the inner surface of the part is shown in figure 4 and in a modified CDP seal shown in figure 5. Sand was also observed in between the labyrinth teeth on the largest diameter of the CDP and modified CDP. It is most likely the sand was present in the air leakage from the centrifugal compressor tip since the labyrinth teeth adjacent to the inlet ports fed by the fourth stage compressor bleed air showed no signs of sand impaction. Micrographs shown in figures 8 and 9 give a rough indication of the size of sand particles taken from the CDP seals in figure 5. The CDP seal labyrinth teeth closest to the impacted sand exhibited some discoloration possibly due to heat exposure, but are otherwise smooth. Some of the remaining teeth on the CDP have nicks possibly due to handling. The modified CDP labyrinth teeth closest to the location of impacted sand are black and rough to the touch. Two of the teeth are slightly rolled-over at the tip.

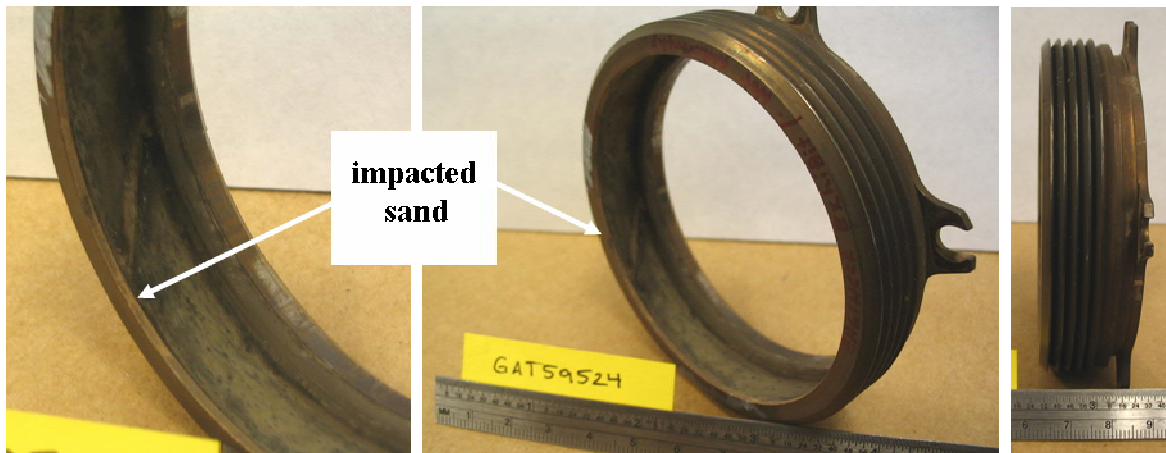
Figure 6.—Inner-balance piston seal.

The inner balance piston (IBP) seal (fig. 6) is a 5-knife labyrinth. A portion of the cooling air from around the combustor is re-directed by the inner balance piston seal to the 3rd stage turbine flowpath.

All three IBP seals were determined to be “undersized” per CCAD with operational hours ranging from 800 to 2000. Some impacted sand was found on the forward lip of one IBP seal as shown in figure 6. A black, oily, soot-like substance was also observed on the inner surface of the IBP. The likely source of the impacted sand is from the cooling air flows past the combustor of the T-700. No sand was observed on or in between the labyrinth teeth.

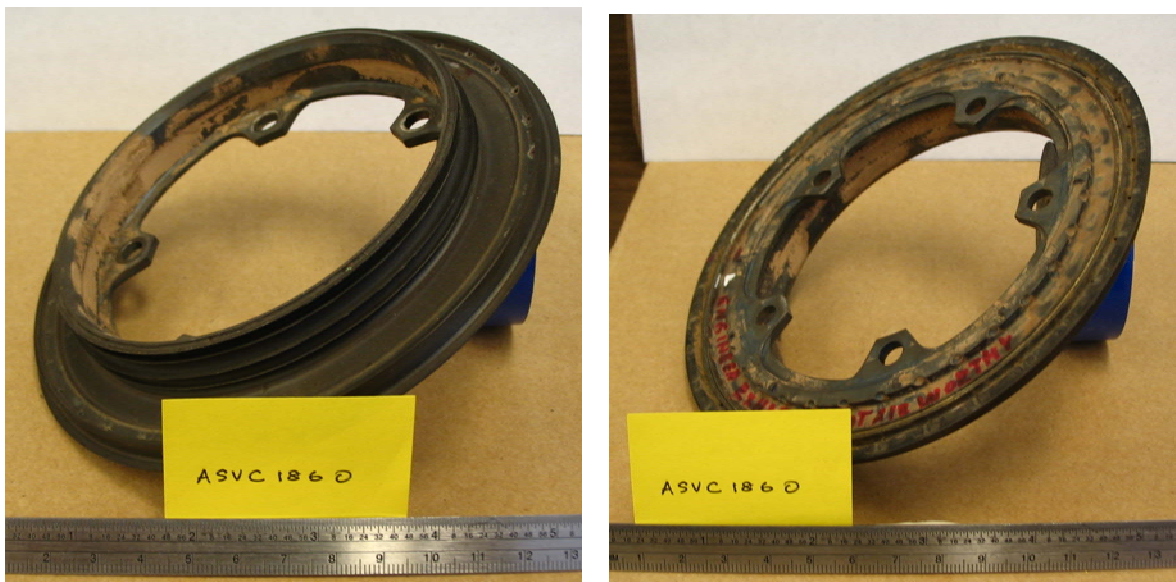
Figure 7.—Forward cooling plate with impacted sand.

Cooling plates (fig. 7) with 4-knife labyrinth teeth are located on the aft and rear of the 1st stage turbine disk. The seals serve to direct cooling air to the 1st and 2nd stage turbine blades. Also, together with the outer balance piston seal they prevent cooling air from escaping to the main gas stream.

Three forward cooling plates were received from CCAD with operation hours ranging from 2000 to 3000 hr. Labyrinth teeth on one cooling plate were blackened and rough to the touch. Coating was chipped on most of the teeth. Another cooling plate, figure 7, showed impacted sand on both the inner surface and backside. Micrographs of the sand taken from this part are shown in figures 10 and 11. The source of the sand is likely from the cooling air flows around the combustor of the T-700.

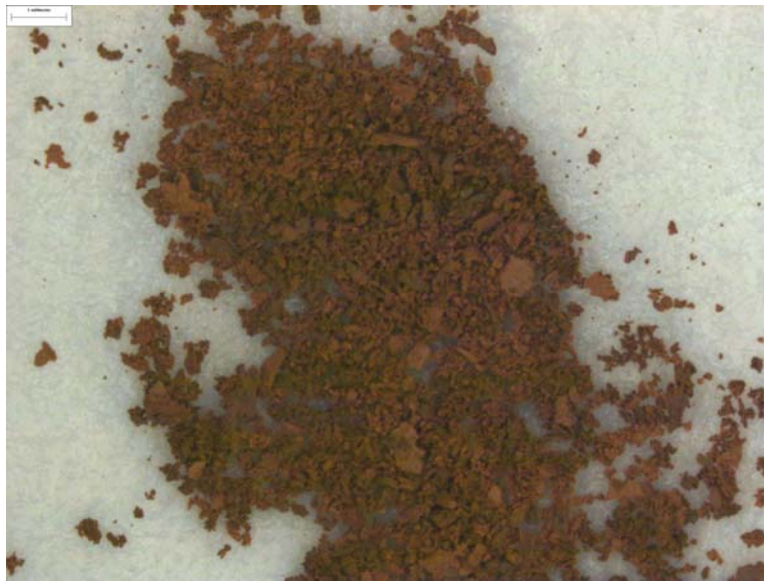
Figure 8.—Micrograph of sand particles from modified CDP seal in figure 5.

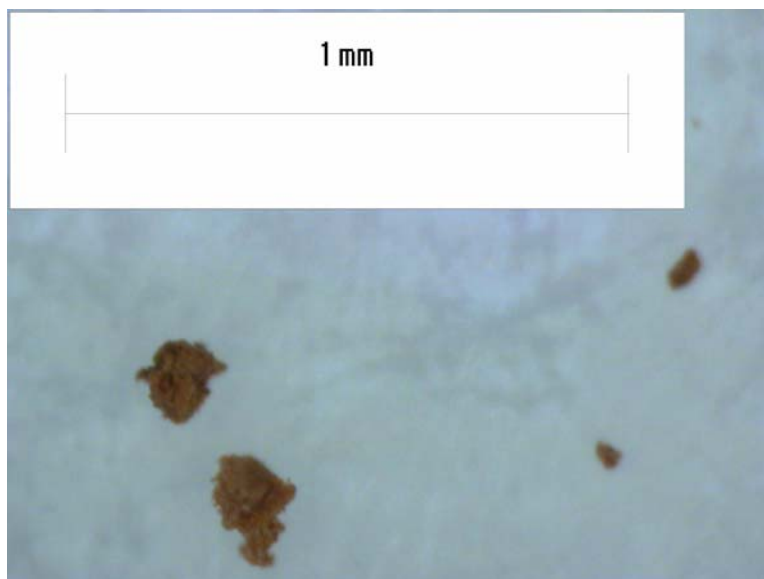
Figure 9.—Close-up micrograph of sand particles from modified CDP seal in figure 5.

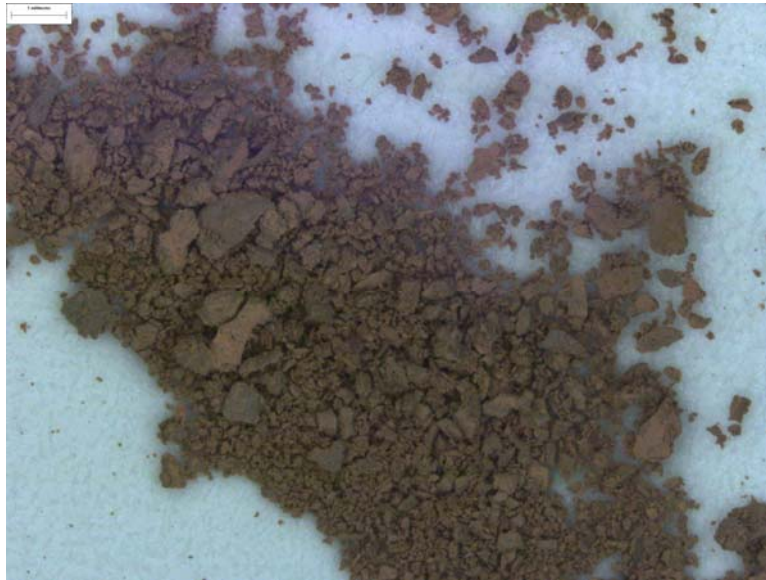
Figure 10.—Micrograph of sand particles from cooling plate, figure 7.

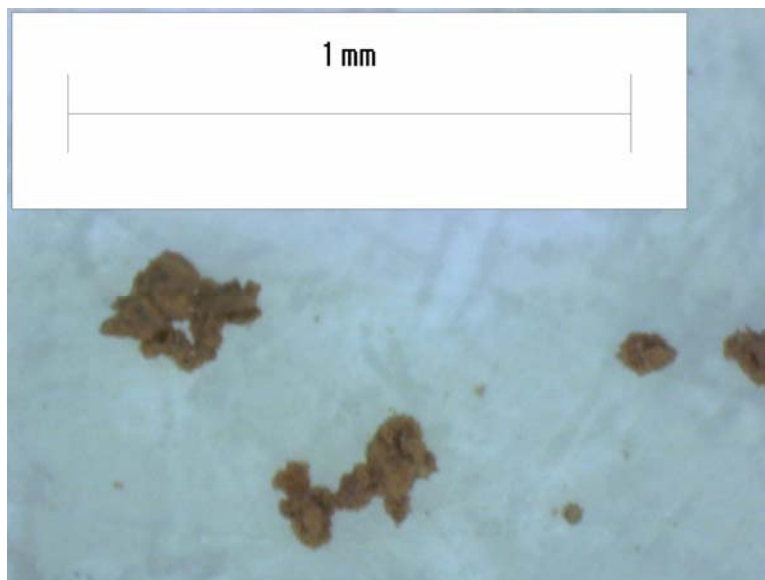
Figure 11.—Close-up micrograph sand particles from cooling plate, figure 7.

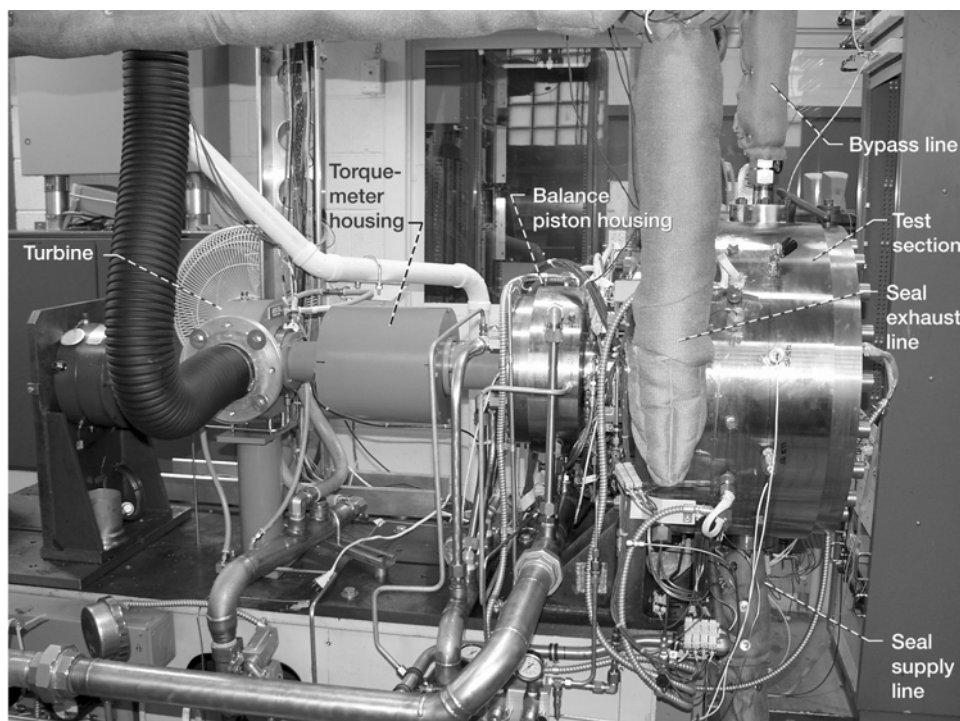
Figure 12.—NASA High Temperature, High Speed Turbine Seal Test Rig.

The High Temperature, High Speed Turbine Seal Test Rig (fig. 12) is designed to measure the leakage performance and power loss of circumferential seals at pressure differentials from 0 to 250 psid, surface speeds in excess of 1200 ft/s and inlet air temperatures from 70 to 1500 °F. The overhung 215.9 mm diameter seal test disk is mounted on a shaft supported by two oil-lubricated bearings and driven by an air turbine. A torque meter is used to measure seal power loss. A more detailed description of the test rig and facility capabilities can be found in reference 21. Comparisons of leakage performance and power loss of brush, finger, and labyrinth seals tested in this facility can be found in papers by Proctor et al. (ref. 22) and Delgado et al. (ref. 23). Generally speaking, brush seals and finger seals have

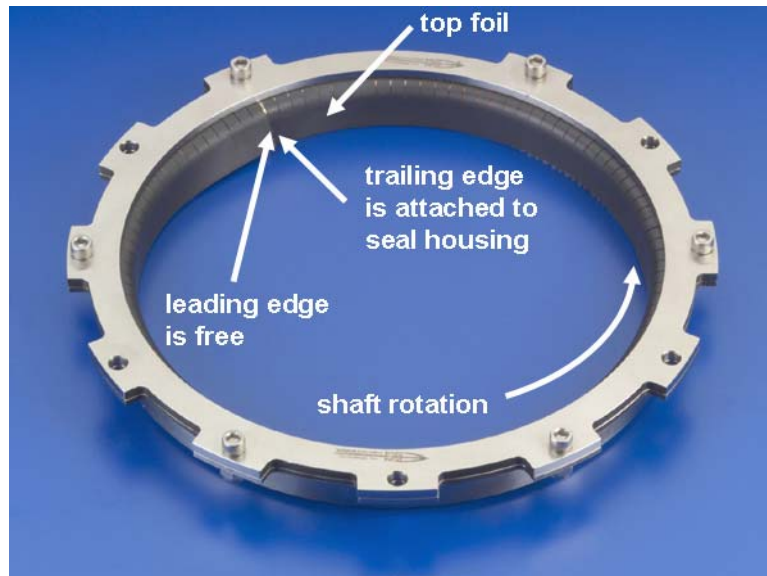
Figure 13.—Mohawk Innovative Technology Inc. foil seal.

The foil seal is one type of noncontacting seal concept that has been investigated (refs. 24 and 25). This circumferential seal is based on journal foil bearing technology in which a top foil anchored at a single circumferential location on the inner diameter of the seal housing wraps around the ID to the anchor point. Corrugated bump foils between the top foil and bearing housing provide stiffness and support to the top foil keeping it close to the rotor, but allowing for rotor growth and dynamic motion. During rotation hydrodynamic forces push the top foil away allowing the rotor to ride on a thin film of air. A foil seal is formed by using two layers of top foils, each with slots on one edge so that it may be formed to block axial flow through the bump foils. The top foils are clocked so that the tabs of one block the flow through the slots of the other. The 8.5 in. diameter seal shown in figure 13 was tested in the NASA facility and was successfully operated up to 25,000 rpm. Its leakage flow factor was about twice that of brush or finger seals. Since this is counter to previous findings with smaller diameter seals it was concluded that there are some scaling issues that need to be addressed (ref. 26).

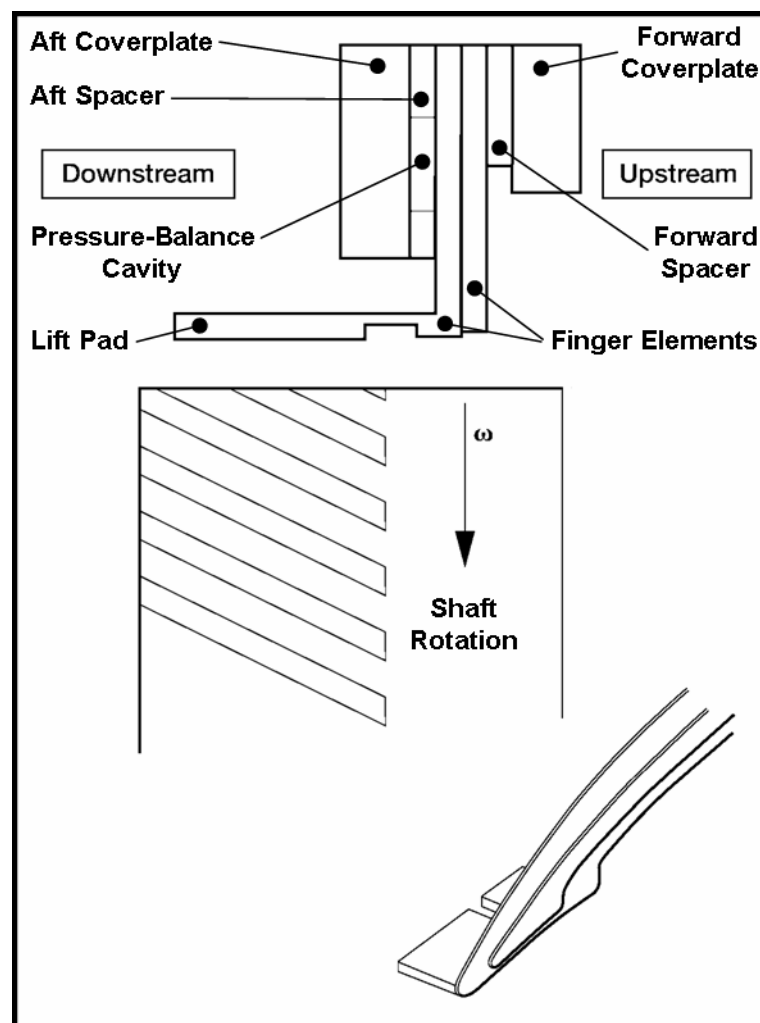
Figure 14.—NASA noncontacting finger seal concept.

The noncontacting finger seal combines the compliant features of the finger seal, which accommodate geometry changes due to thermal and dynamic conditions, with hydrodynamic and/or hydrostatic lift pads, which ride on a thin film of air and prevent contact during rotation. Early noncontacting finger seals had lift pads extending from the fingers in both the upstream and downstream directions (ref. 27). The NASA-patented noncontacting finger seal, shown in figure 14, eliminates the lift pads extending in the upstream direction to reduce hydrostatic closing forces on the upstream finger element (ref. 28). This seal is comprised of a high pressure finger element adjacent to a low pressure finger element with lift pads sandwiched between a forward spacer and cover plate and an aft spacer and cover plate. The high pressure and low pressure finger element are oriented so that the fingers of one cover the slots between

the fingers of the other. A series of slots in the forward and aft spacers and holes in the finger laminates allows high pressure air to flow into the pressure balance cavity formed by the aft spacer and cover plate and low pressure finger laminate. The balance cavity is necessary to minimize hysteresis in the seal due to friction between the fingers and the seal dam (ref. 29). Various geometries on the lift pad inner diameter and on the rotor outer diameter can be used to create an opening force between the rotor and the seal. This opening force must be in balance with the pressure closing force, which is a function of the pressure differential across the seal, finger stiffness, and friction within the seal. The opening force may be hydrodynamic in nature and require shaft rotation to be generated or it may be hydrostatically generated once a pressure differential is applied or it may be a combination of the two. Three-dimensional fluid analysis and some structural analysis has been done to gain understanding and select specific designs for testing (refs. 30 and 31). Room temperature tests of noncontacting finger seals with three different lift pad geometries (circumferential wedge, circumferential and axial wedge, and a Rayleigh step) conducted at pressure differentials up to 30 psid and speeds up to 15,000 rpm have demonstrated noncontacting operation (refs. 32 and 33). Hardware to test a noncontacting finger seal with concentric lift pads adjacent to a rotor with a herringbone groove pattern has been fabricated for testing in NASA's High Temperature, High Speed Turbine Seal Test Facility. Test data will be used to verify, develop, and refine analysis tools and design methodologies.

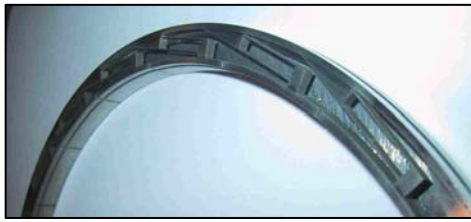
Figure 15.—Hybrid brush seal.

Hybrid brush seal technology continues to be investigated and developed. The hybrid brush seal (HBS) shown in figure 15 is a promising noncontacting, low leakage seal technology that has application to Army engines as well as commercial and advanced gas turbine engines. Hydrostatic lift pads are supported by a spring housing (fig. 16) that is radially soft and axially stiff. A brush seal is used as a secondary seal and provides damping to the hydrostatic bearing surface. Computational fluid dynamic analysis provides a means to determine the HBS functionality, such as stiffness and damping, pad pressure forces, and clearance. The HBS geometry can be modified to provide a larger or smaller operational clearance. Further, the hybrid brush seal can be installed with a larger cold clearance and maintain a smaller operational effective clearance, which means low leakage rates (ref. 34).

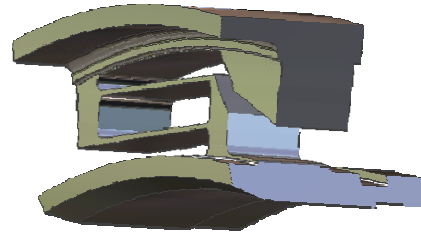
Figure 16.—Hydrostatic lift pad and spring housing section.
